LuK Service Info

LuK Double Disc Clutches

Transport damage due to incorrect handling

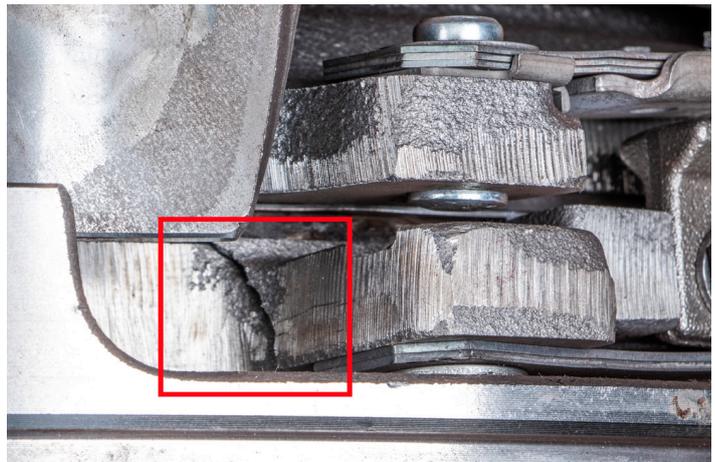
Image 1: Cam break at the fixture of the tangential leaf spring

The main cause of this damage is lateral impact loads that result from improper loading methods or inadequate securing of the load.

In most cases, these impact loads cause cam breaks at the fixtures of the tangential leaf springs (Fig. 1), which then lead to problems disconnecting the clutch. Furthermore, fragments of the cam or parts of the tangential leaf spring can suddenly work loose even at low speeds and cause serious damage to the bell housing. For this reason, a damaged pressure plate must not be installed under any circumstances because very high consequential costs can be expected.

- The condition of the clutch packaging on arrival must be more or less damage free. If the packaging has been damaged during transportation, conduct a detailed visual inspection on the clutch to check for the damage mentioned above
- Any impact loads on the clutch, especially lateral impact loads, must be prevented
- As the clutch is relatively heavy, it is worth using a suitable lifting device to handle the component
