Technical *Info*

Timing belt CT 817 Daihatsu Cuore, all model years

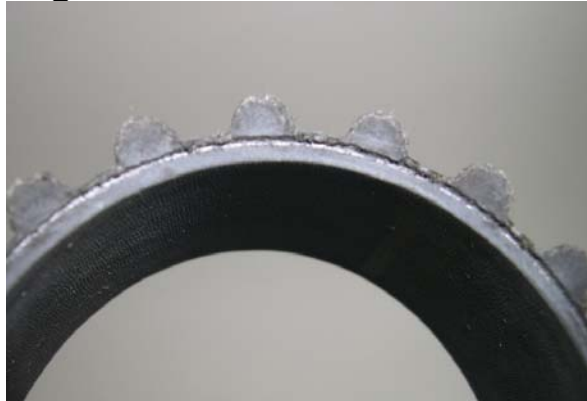
Fig. 1
Edges of the CT 817

The belt is frayed on the sides and has the looks of sloppy work.

The CT817's tensile member is Kevlar. For technical reasons, the edges appear as in Fig. 1 after being cut.

There is no cause for concern in using the belts. No material flaw is involved here.
