Technical *Info*

Replacement of Timing Belt Kit CT 946 K2 with Kit CT 1044 K1

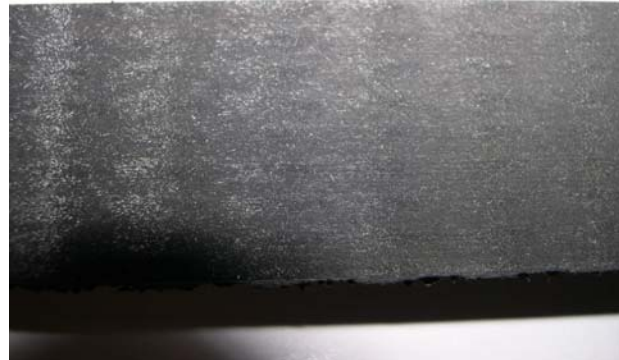
Fig. 1
CT 946

The belt supplied with CT 1044 K1 is different in terms of appearance and number identification from the CT 946 belt installed so far. **(Fig. 1)**

Kit CT 946 K2 is no longer available and has been replaced by CT 1044 K1. The distinguishing engine number is thus omitted.

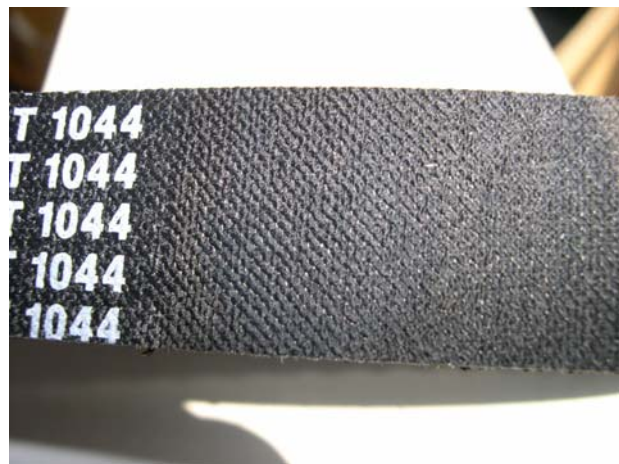
Fig. 2
CT 1044 with belt back fabric

The CT 1044 is reinforced with additional belt back fabric and can also be used for the older TDI engines. **(Fig. 2)**
