Technical *data*

Conversion of 6PK1140 ELAST V-ribbed belt to 6PK1070 for Audi, VW, Seat and Skoda 1.6 TDI and 2.0 TDI (common rail)

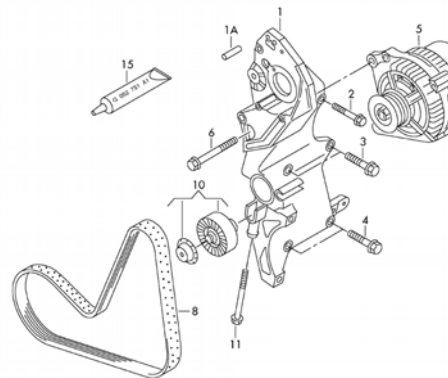
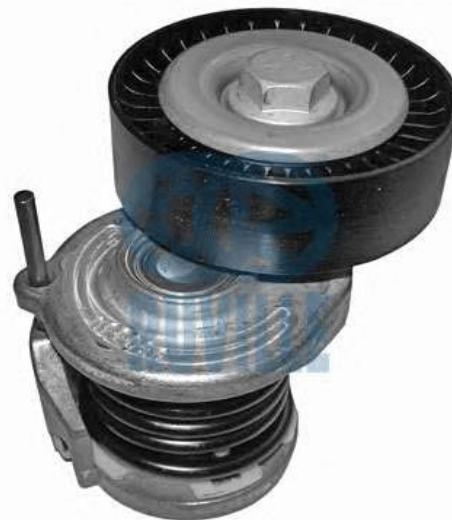
Belt drive

The 6PK1140 ELAST V-ribbed belt (OE no. 03L903137G) is being discontinued. The 6PK1070 replacement belt (OE no. 03L903137) cannot however be installed directly.

During plant trials the modified design apparently contributed to improved running properties, and because of that the new design should now be used when the belt has to be replaced.

The idler pulley (OE no. 03L145276) should be replaced with a tensioning element with roller (OE no. 038903315AH). Together with the new belt, the tensioner is to be installed with the new M 8x50 hexagon head screw (OE-Nr. N10640801).
