Technical *Info*

Failure of idler pulley due to blocking of cover layer – CT 1092 K1 (1.6-l diesel; 9H engines in Peugeot, Citroën, Ford, Fiat, Mazda, Mini, and Volvo)

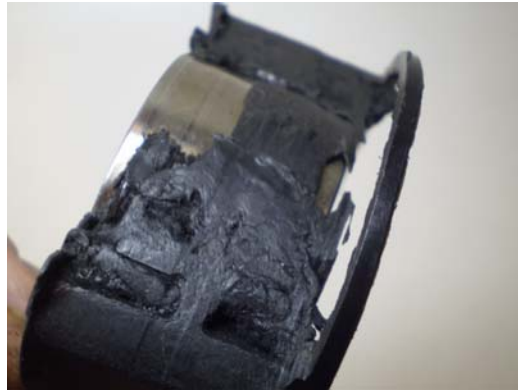
The belt drive fails due to the defective idler pulley. Part of the plastic cover has been ground through.

Always make sure that the cover of the toothed belt drive is positioned correctly and check for any potential distortion due to heat input. Long-term operation can be ensured only when the pulleys can rotate without obstruction.

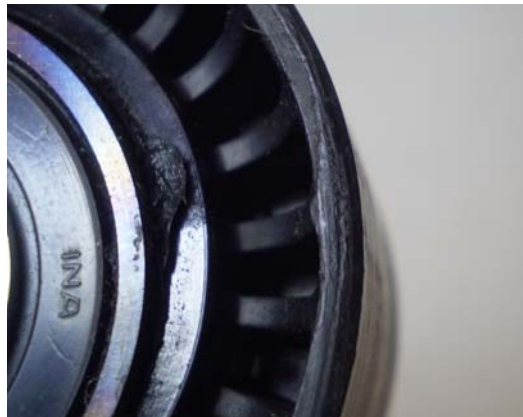
The idler pulley becomes blocked due to non-permissible contact with the cover and fails after a short period due to the belt sliding over the top.
