# Technical *Info*

## Belt drive makes noise shortly after installation of CT 908K1 kit (VW/Audi/Seat/Skoda 1.6/2.0 L 8 V)

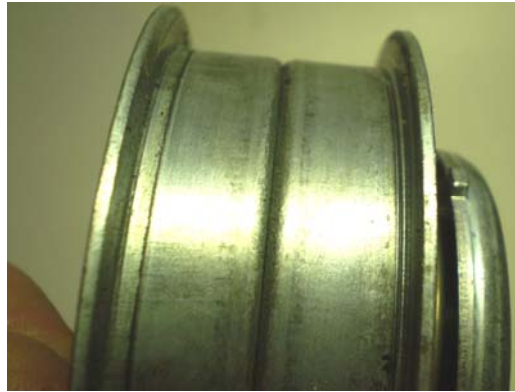
Shortly after installation of the kit, noise came from the cold engine (belt not aligning).

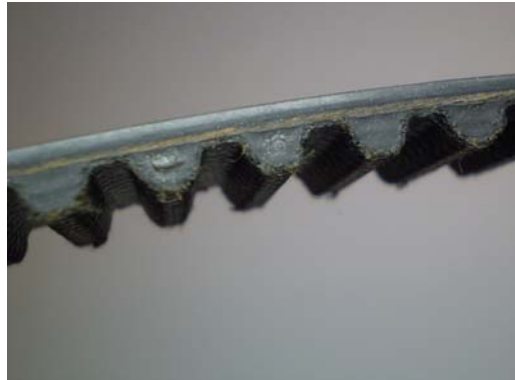
The timing belt rubs up against the inside flange of the tensioner pulley, producing a squeaking sound.
