SWAG 30 94 0308

To fit:
various Volkswagen, Audi, SEAT and Škoda models

Repl. no. 03L 903 137 T S1

Auxiliary belt kit with belt tensioner and bolt

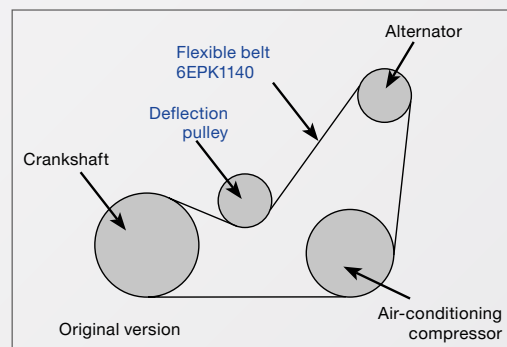
Figure 1

The original version of the auxiliary belt drive was driven by an elastic multi-V belt and a deflection pulley which suffered from wear, leading to insufficient tension of the auxiliary belt. (Fig 1) To improve the NVH (noise, vibration, harshness) characteristics, the vehicle manufacturer redesigned the components of the auxiliary belt drive.
