SWAG 33 10 8022

To fit:
various Audi, SEAT, Skoda and Volkswagen
models with 1.6 & 2.0 TDi engines.

Water Pump

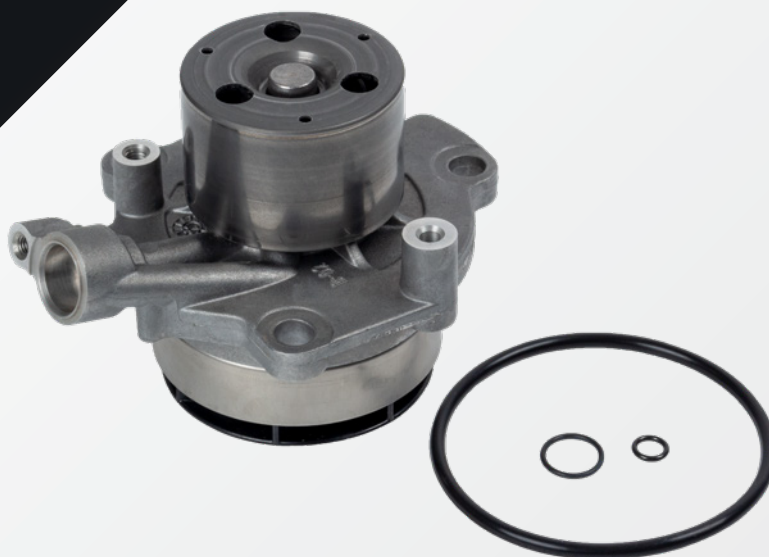
The engine is overheating, the coolant temperature gauge reads over 110° C and the interior heater is performing poorly. Additionally, cooling system fault codes may be logged in the engine-control unit (ECU).

The water pump fitted to these vehicles has an ECU-controlled collar, which interrupts the coolant flow to make the engine more thermally-efficient. However, the control collar can seize, or the plastic impeller can break-up or come away from the shaft.

Ensure the engine is cool, then remove the coolant-filler cap. Remove the small pipe to the coolant header tank and hold this over the filler neck of the header tank. There should be a small trickle of coolant flowing with the engine at idle, and this should increase in flow upon increasing the engine speed. If the flow rate does not increase, this would suggest a faulty water pump.

Replace the defective water pump with SWAG 33 10 8022, which features an improved control-collar design; this has been thoroughly tested to eliminate the potential failure of the original water pump.

The solenoid valve must be removed from the old original pump and fitted to the new pump, including new seals, which are provided in the kit.

Fill the cooling system with the correct coolant, then vacuum-bleed the cooling system. Finally, carry out the cooling system bleeding procedure using a suitable serial-diagnostic tool to expel all the air from the cooling system.
