SWAG 83 93 1564, 83 93 2868

To Fit: Mazda 3 (BK), MX-5 (NC)

Wheel Bearing Kits

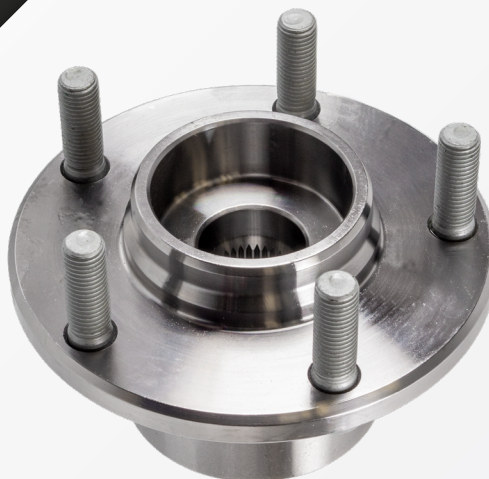
After the installation of a new wheel bearing or CV joint the vehicle emits a click/clunk type sound when moving either forwards or backwards from a stationary position.

The noise is a result of a small amount of movement between the wheel bearing/drive flange and the outer CV joint.

Thoroughly clean the mating surface between the wheel bearing/drive flange and the outer CV joint using a suitable degreaser. When the mating surface has been degreased apply a light coating of molybdenum grease (SWAG 99 83 0001) between the two surfaces and reassemble using a new hub nut.

Be careful not to get grease on the brake disc or pads.
