This new version replaces all previous versions. Please replace SI-110810

Whistling noise after short amount of time, bearing clearance is not increased

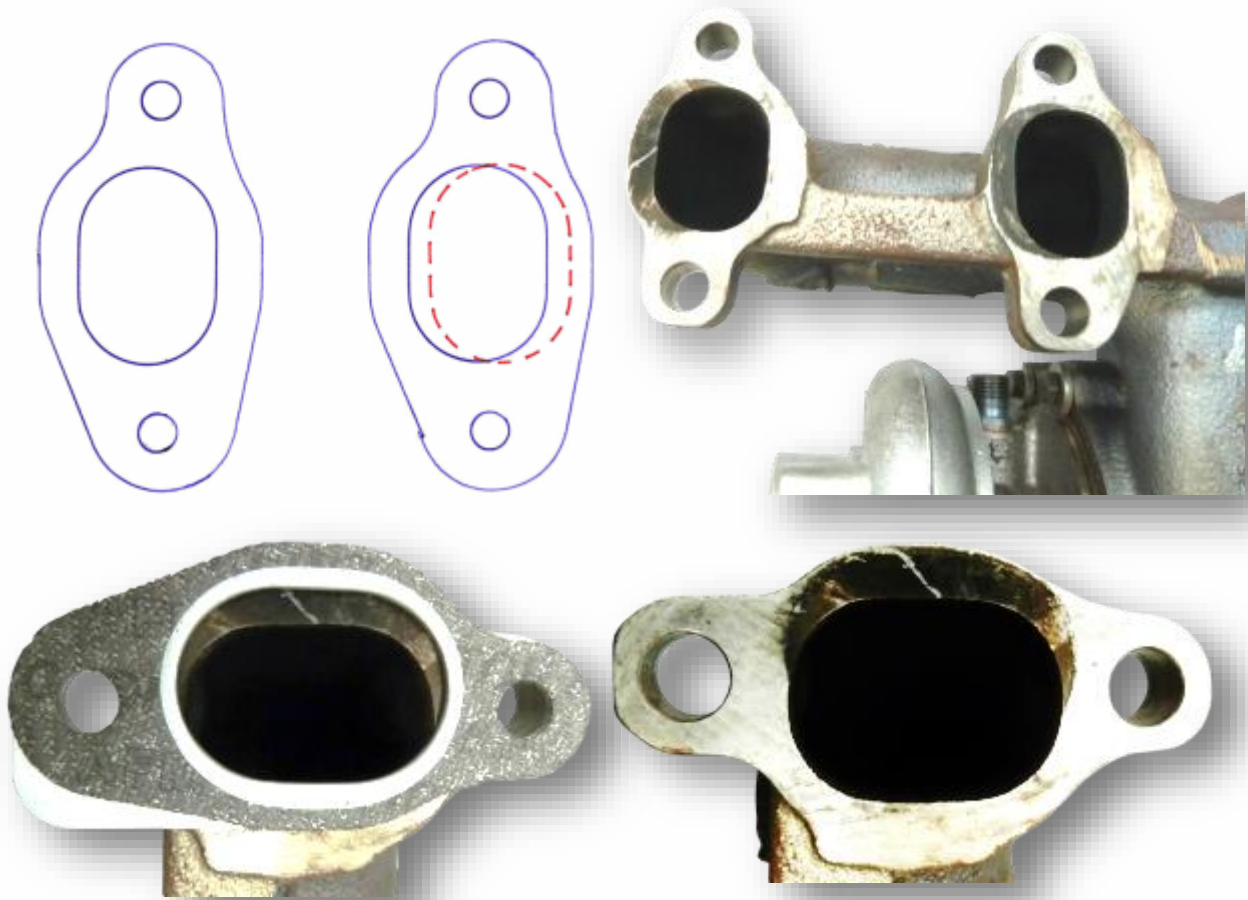
When fitting the individual gaskets of the exhaust manifold, please have a good look at their position. The passage may not be in the center and do not lie on the waste gas flue of manifold when mounted wrongly. This may already lead to leakages and whistling noises after driving for a short amount of time.
