Whistling noises after installing the new turbocharger

Vehicle Manufacturer: Mercedes

Vehicle: (CLS, C, E) 220 CDI, 250 CDI ; Sprinter

BTS reference: T915488, T915489, T915834 **BTS-Service-Set-Nr:** T981465

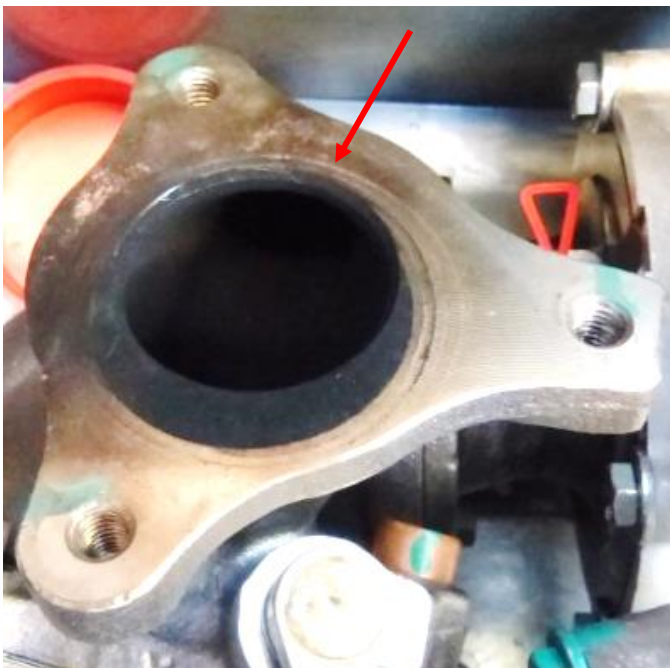
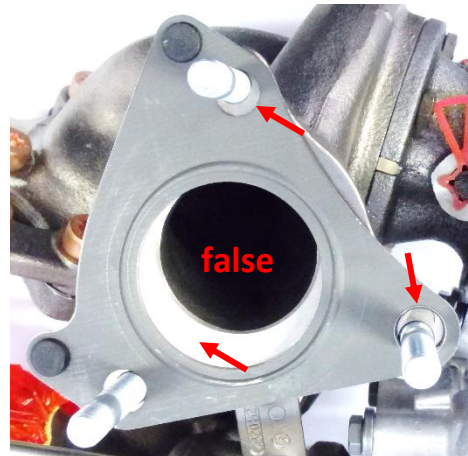
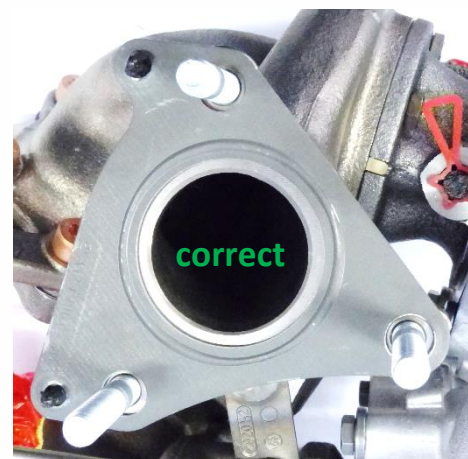
The exhaust gas seal between turbocharger and exhaust manifold can be placed mirror-inverted when mounting the turbocharger to the exhaust manifold. Screwing in the connecting screws is possible without any noticeable obstacle.

In this case, the exhaust gasket fails and escaping exhaust gases cause the detected whistling noise.

During assembly, it must be ensured that the exhaust gasket is correctly installed. Test the correct installation position on the turbocharger.
