Boost controller error due to stiff VTG-unit, cause defective EGR cooler

Vehicle Manufacturer: VW

Vehicle: Crafter, Amarok 2.0 tdi

BTS reference: T916320 **BTS-Service-Set-Nr:** Txxxxxxxxx

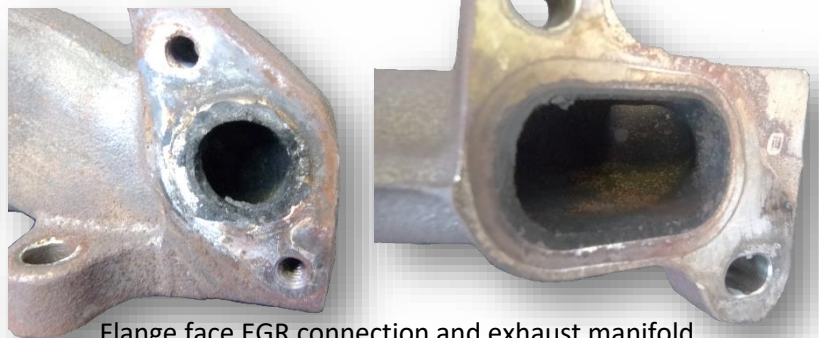
Examine the turbocharger to be replaced in the exhaust manifold and turbine exhaust for deposits of rust or light lime scale. If the EGR cooler leaks, after shutting off the engine, cooling water presses into the exhaust manifold and into the VTG unit of the turbocharger. There it comes to corrosion and lime scale deposits, which leads to the stiffness up to the blocking of the VTG. Even small amounts of cooling water loss are sufficient.

Flange face EGR connection and exhaust manifold

Check the EGR cooler for leaks in the cooling water circuit and replace if necessary. So an expensive repetition damage can be avoided at the new turbocharger.

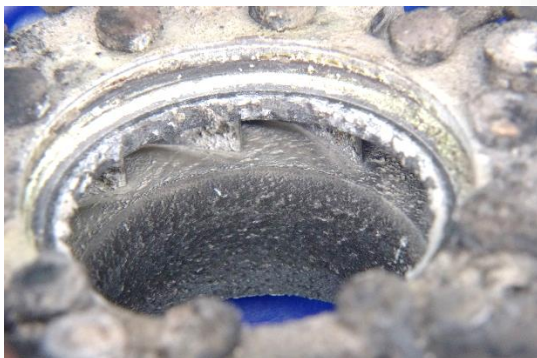
Lime deposits and rust in the VTG unit
