### Internal engine coking of the oil circuit lead to early bearing damage on the turbocharger

**Vehicle Manufacturer:** Hyundai

**Vehicle:** H 1 Cargo 2.5.CRD

**Engine code:** D4CB

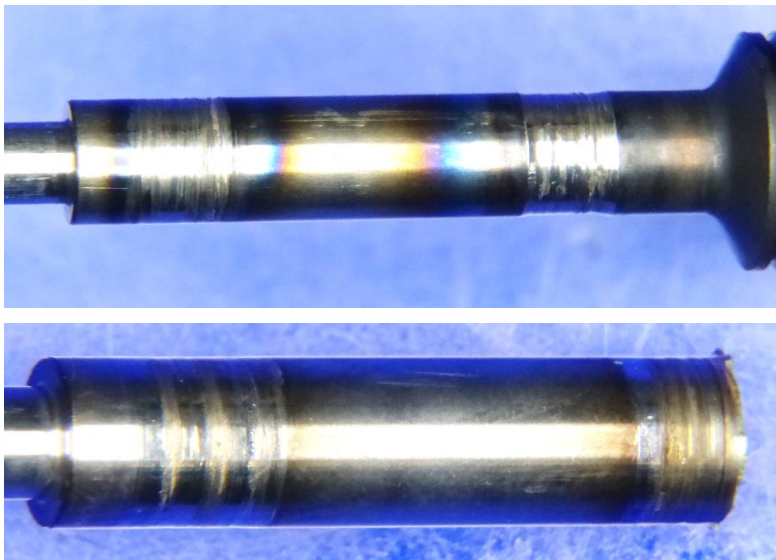
These vehicles are generally known to us by early recurring damage to the turbocharger due to extreme wear in the bearing of the rotor shaft or also deficient lubrication damage.

After running 150,000 km or more, massive oil carbon deposits in the oil pan, oil suction strainer and oil filtration elements are not uncommon.

Typical damage characteristics of lubrication deficiency damage

If the internal engine oil circuit is poorly conditioned, the oil pump with oil suction strainer and vacuum pump must be checked for contamination and wear and replaced if necessary. The oil sump and oil cooler must be cleaned mechanically. A final engine flush should be considered.

The oil inlet line and oil outlet line from the turbocharger must always be replaced.
