Soot deposits on bearing housing, Leakage on flange surface of exhaust manifold

Vehicle Manufacturer: Peugeot, Citroën

Vehicle: 207, 208, 308, 3008, 508, RCZ, C4, C5, DS3 1.6 THP / 1.6 16V

Engine code: 5FE (EP6CDTM), 5FE (EP6CDTMD), 5FN (EP6CDT), 5FR (EP6DT), 5FT (EP6DT), 5FV (EP6CDT), 5FX (EP6DT)

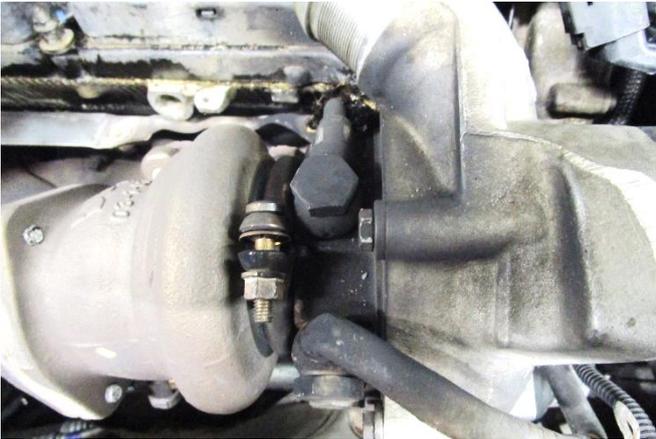
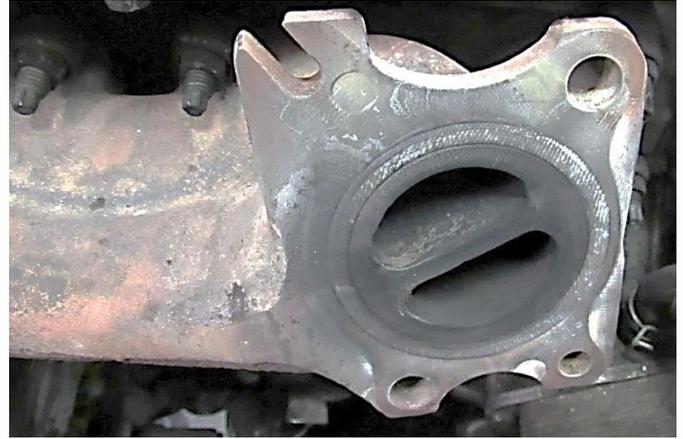
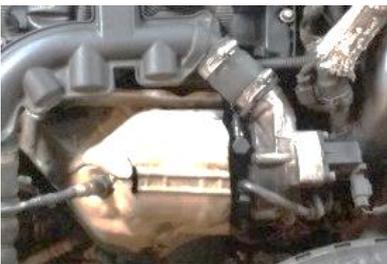
In certain cases, there are complaints of a smell of exhaust gas in the passenger compartment. In the area of the turbocharger bearing housing (oil inlet line), sooting due to exhaust gas can be detected.

The impression given that the exhaust gases escape behind the V-band clamp between the turbine housing and the turbocharger bearing housing is not always correct. Leakage can also be present on the flange surface of the turbocharger to the exhaust manifold or on the exhaust manifold itself (distortion or cracking).

Check exhaust manifold for leaks at cylinder head, or check exhaust manifold for cracks.

Check the flat surface of the exhaust manifold for evenness before installing the turbocharger. The gasket to be used on the turbine housing cannot permanently seal any gaps between the components..
