### Boost controller error due to stiff VTG-unit, cause defective EGR cooler ?

**Vehicle Manufacturer:** VW

**Vehicle:** T6 2.0 tdi

**Engine code:** CXHA, CXHB, DNAA

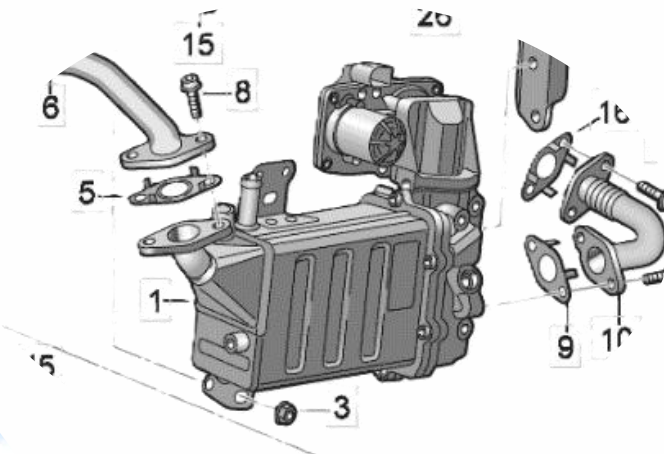
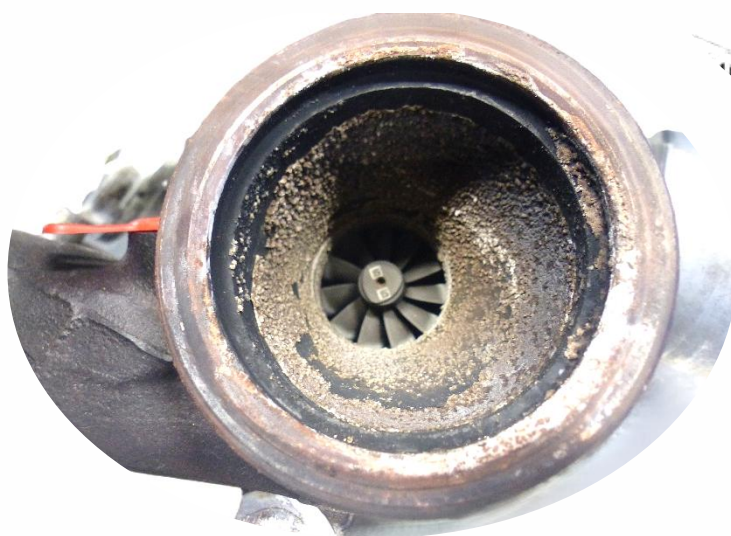
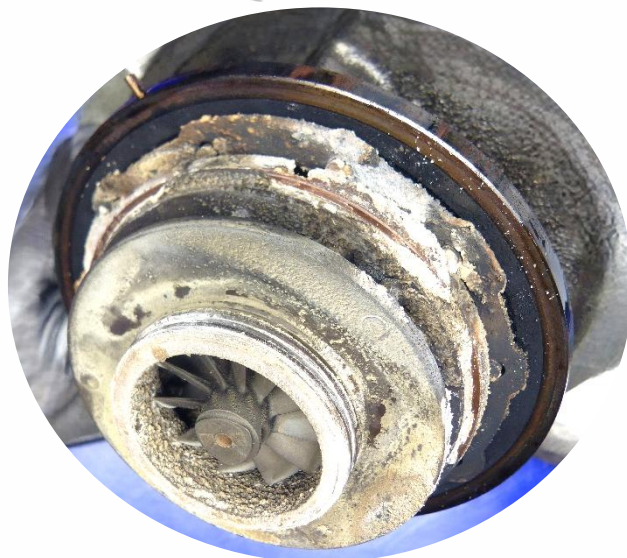
Examine the turbocharger to be replaced in the exhaust manifold and turbine exhaust for deposits of rust or light lime scale. If the EGR cooler leaks, after shutting off the engine, cooling water presses into the exhaust manifold and into the VTG unit of the turbocharger. There it comes to corrosion and lime scale deposits, which leads to the stiffness up to the blocking of the VTG. Even small amounts of cooling water loss are sufficient.

Check the EGR cooler for leaks in the cooling water circuit and replace if necessary. So an expensive repetition damage can be avoided at the new turbocharger.
