### Damage caused by foreign objects on the intake side, defective components in the low-pressure EGR system

**Vehicle Manufacturer:** LAND ROVER ; JAGUAR

**Vehicle:** Range Rover Evoque; Range Rover Velar; Discovery; XE; XF II; E-Pace; F-Pace 2.0 D

**BTS reference:** T917572      **BTS-Service-Set-Nr:** T981621; T981622

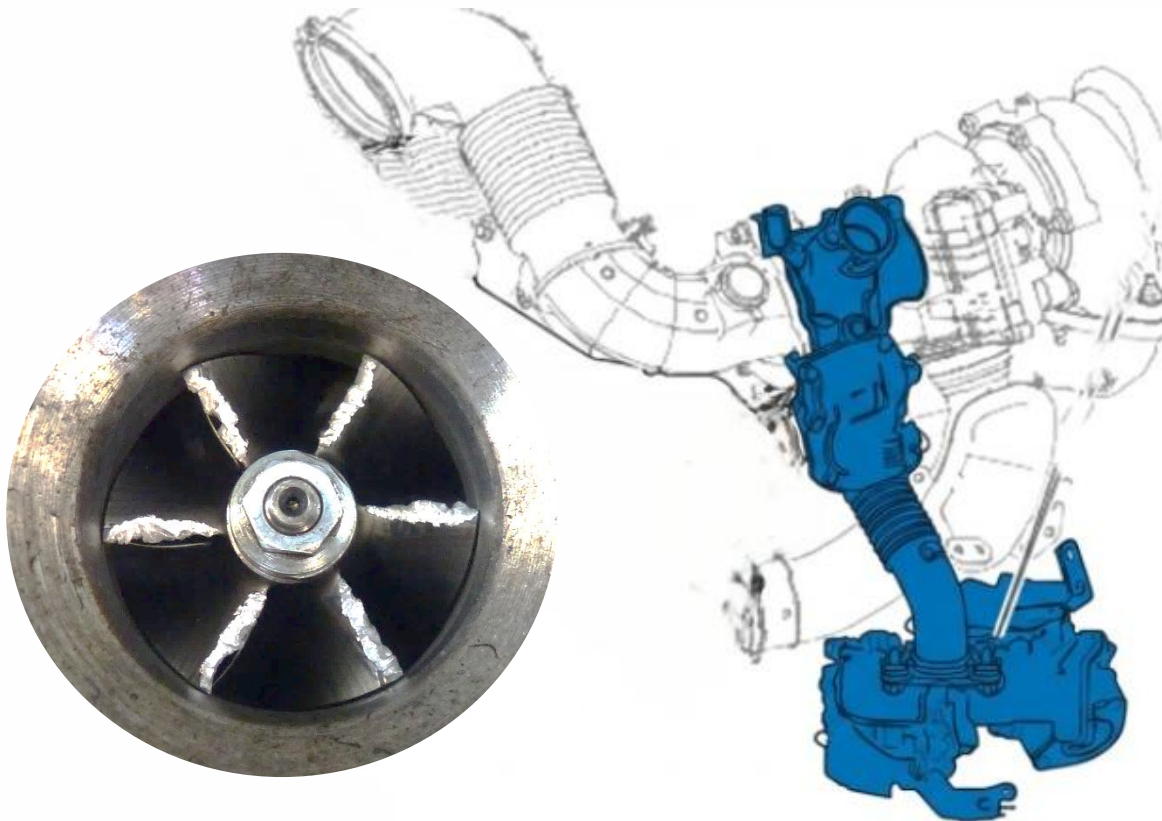
In the vehicles listed below, damage is evident in the form of damaged air inlet edges on the compressor wheel. This is caused by hard foreign objects that are aspirated by the compressor along with the fresh air.

Inspect all components from the air filter housing to the turbocharger's compressor inlet for damaged parts. Components of the crankcase ventilation system should also be checked for damage.

On vehicles with low-pressure EGR, inspect all components down to the diesel particulate filter for damage. The diesel particulate filter should also be inspected on the exhaust outlet side for cracks.

Damaged parts must be replaced in all situations.

Check all components for foreign objects and any deposits. This will help prevent costly recurring damage to the new turbocharger.
