Audi A4 Clutch Replacement

The model featured in this article is a 2008 A4 Avant B7 2.0 TDi fitted with a 01X front wheel drive 6-speed transmission. It was reported that the vehicle had clutch judder - when cold - and a rattling noise coming from the transmission area. This required the transmission to be removed and the clutch and flywheel to be inspected in order to fully diagnose the fault and rectify it.

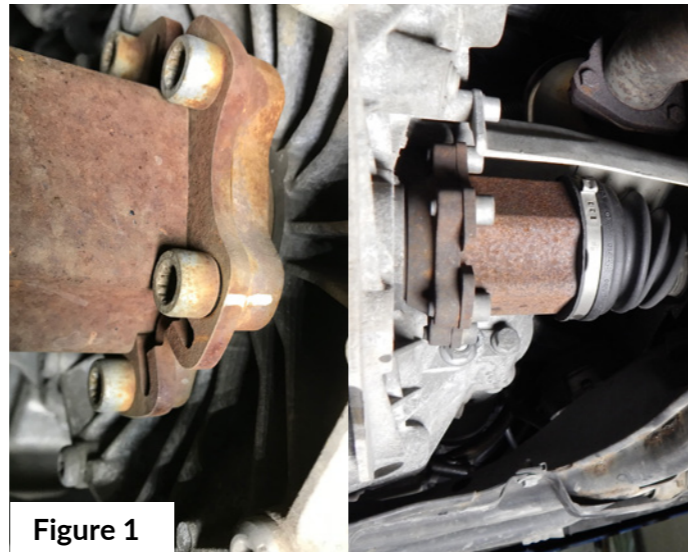
Figure 1

The heatshield (above the right hand driveshaft) was then removed. Following this, the original position of each driveshaft was marked before all of the bolts that retain them to the drive flanges were undone. After marking, they were positioned to one side. (Fig. 1)

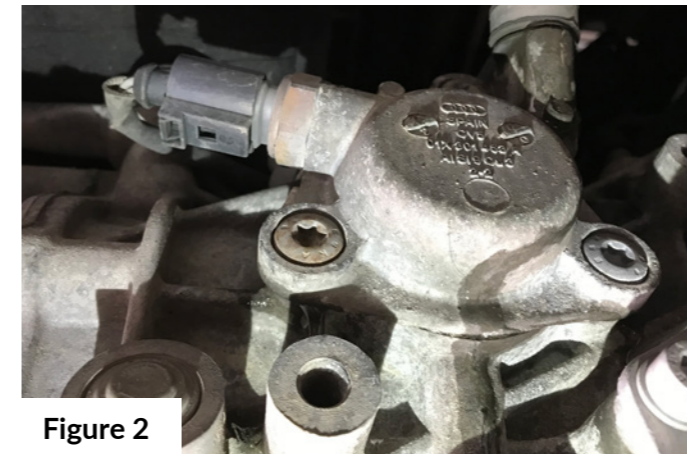
Figure 2

On the right hand side of the transmission the reverse lamp switch was located. The wiring loom was unclipped and then secured. Above this switch was one end of the gear selector rod. The retaining bolt was removed and put to one side. (Fig 2)

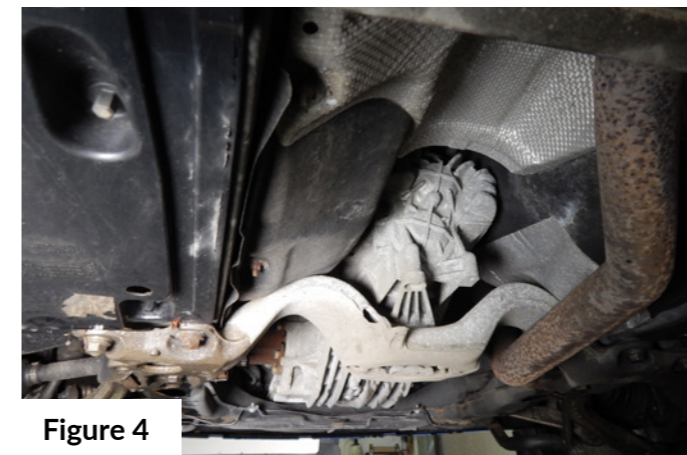
Figure 4

ProTip: This can be achieved by lowering the exhaust - either by unbolting it from the manifold or by removing the exhaust hanger (located in the middle of the exhaust) in order to give enough room between the exhaust and the floor of the car. (Fig 4)

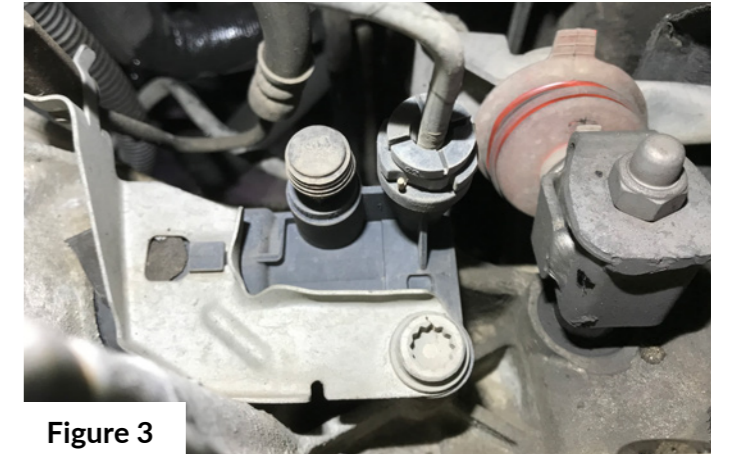
Figure 3

On the left, the clutch slave cylinder and the other end of the gear selector rod was located. The hydraulic hose was clamped to the slave cylinder to prevent any fluid loss. The pipe was then unclipped from the slave cylinder and capped at the end to reduce dirt ingress. The retaining nut from the gear selector was then unfastened and removed. (Fig 3)
