## LuK Service Info

# Misalignment of diaphragm spring fingers

Manufacturers: PSA/Peugeot, Citroën

LuK RepSet: 623 3325 00  
623 3325 09  
623 3325 33  
601 0021 00

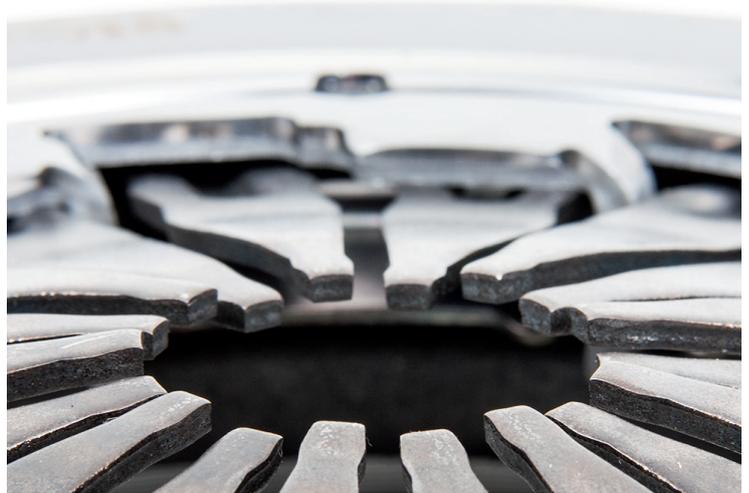
Fig. 1: Misalignment of diaphragm spring fingers on a dismantled clutch

The diaphragm spring fingers of the pressure plate in the LuK RepSet are misaligned in its uninstalled condition (Fig. 1). This design characteristic is safe and does not represent a component defect.

During the installation of the clutch, the diaphragm spring aligns itself to its working position. In so doing, the diaphragm spring fingers align themselves properly and provide for the fully reliable operation of the clutch.

All components of every LuK RepSet undergo 100% inspection on the assembly line. They meet the technical specifications and are suitable for unrestricted use on the vehicles listed in the catalog.
