febi 33748

Vauxhall, Opel Corsa C, Combo C, Tigra, Vita

Wiper motor

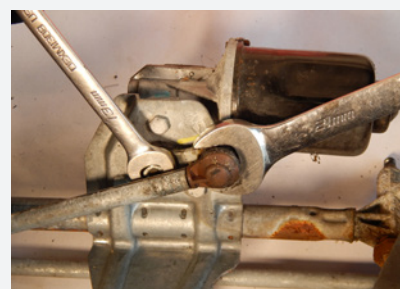
Figure 1

Undo the linkage-retaining nut to the motor-splined drive and remove the three motor-fixing bolts; this is in order to remove the motor from the linkage. (Fig. 1&2) Attach the new motor to the linkage, which is supplied with self-tapping screws that thread into the fixing holes when the screws are inserted into the new unit. (Fig.3)

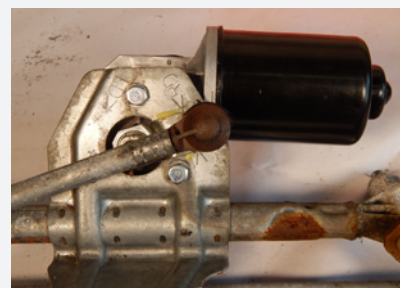
Figure 4

Align the wiper linkage to the splined drive of the motor, making sure it is aligned between the arrows marked LH or RH - depending on vehicle specification - and tighten the new nut supplied. (Fig.4)
