febi 33986

Renault Clio 3, Modus

Engine mounting

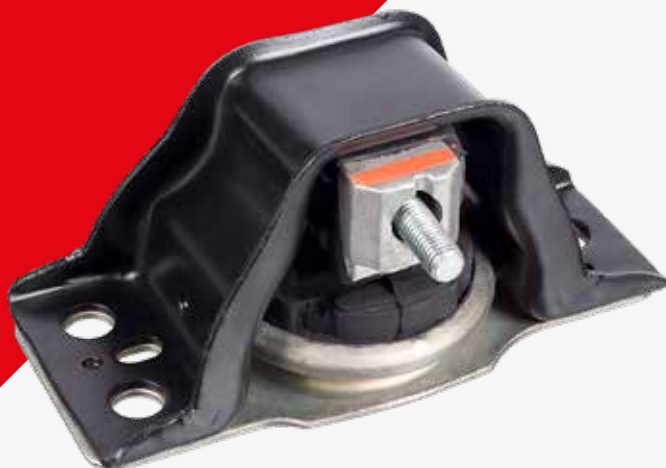
When the vehicle is in neutral with the engine idling, a vibration/judder can be felt through the vehicle dashboard, accelerator, brake, clutch pedal and seat. Additionally, a 'humming' noise can be heard.

When exposed to the elements and hot and cold heat cycles, the engine mount's rubber component begins to degrade. In turn, this degradation causes excessive movement of the engine mount.

Make sure the vibration is being caused by the engine mount by increasing the engine speed to see if the noise disappears or changes tone.

Get the help of an assistant; they can manipulate the mounting by adding pressure to it using a lever bar, which applies a load to the engine mount in several areas. If the noise disappears, the mounting should be replaced.
