24V, 3-Core, Working length 3m

Always connected - With electrical coils by febi

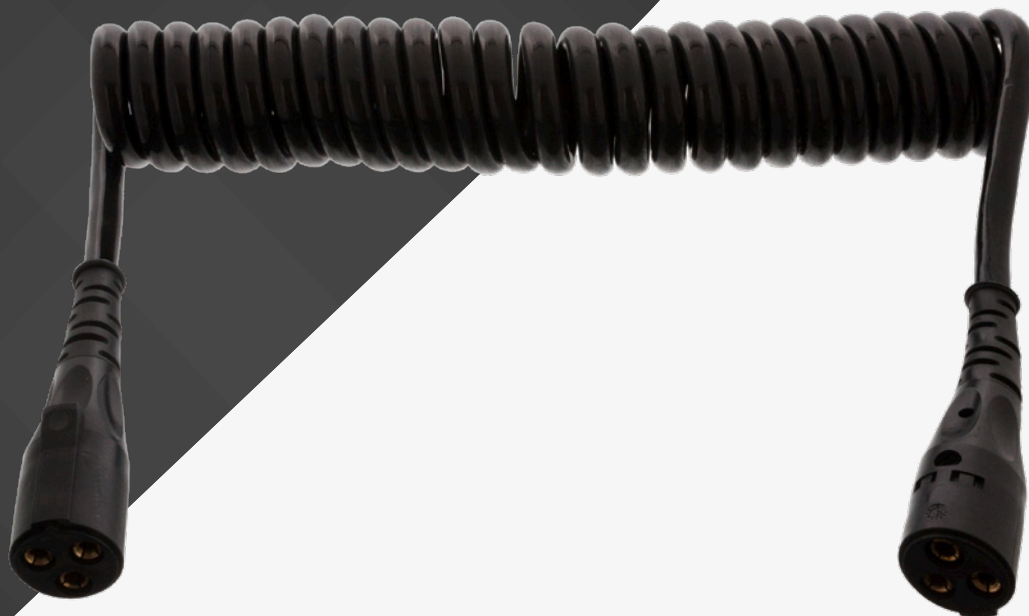
Modern vehicles strongly depend on adequate power supply to function properly. This also applies to electrical elevator tailboards on commercial vehicles. A three-core electrical coil is typically required to ensure suitable voltage supply. If this coil fails, due to cable break or fraying, the elevator tailboard can no longer be operated.

Cables in low quality electrical coils often contain insufficient copper material. An exceedingly small wire size leads to increased resistance, which can result in raised cable temperatures, and in extreme cases it will end in a short-circuit fault.
