DPF359.03

Assembly/disassembly recommendations

IDENTIFICATION OF CRANKSHAFT PULLEY DPF359.03

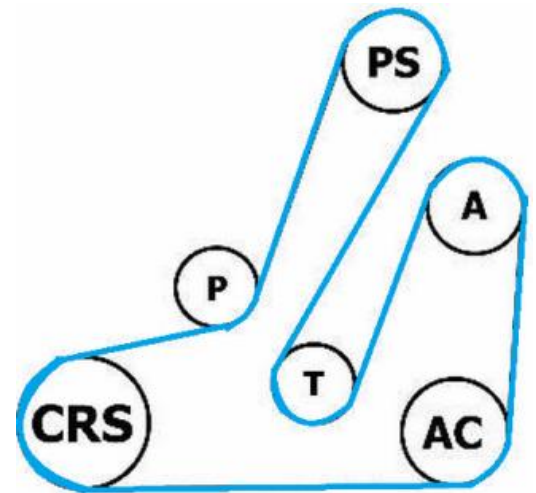
Other parts in the belt system being misaligned or defective:

CRS	Crankshaft	T	Tensioner roller
P	Return pulley	PS	Power steering pump
A	Alternator	AC	Air-conditioning compressor

- The overrunning alternator pulley should be replaced at the same time as the belt, otherwise the belt system might become misaligned.
- A misaligned accessory belt can cause major engine damage

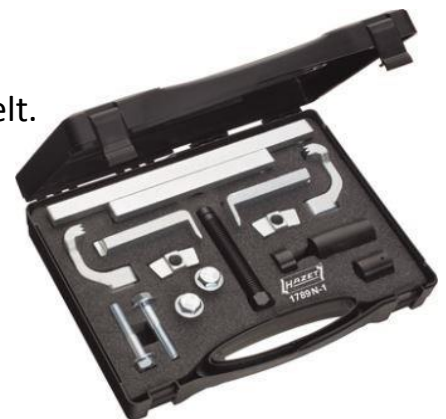
- Torque wrench
- HAZET tool set: (pulley extractor)
Ref.1789N-1 for pulley removal

Use a HAZET or similar extractor.
