# SWAG 33 11 3903

To fit: Various Volkswagen, Audi, SEAT and Škoda models

## Anti Roll Bar Bush

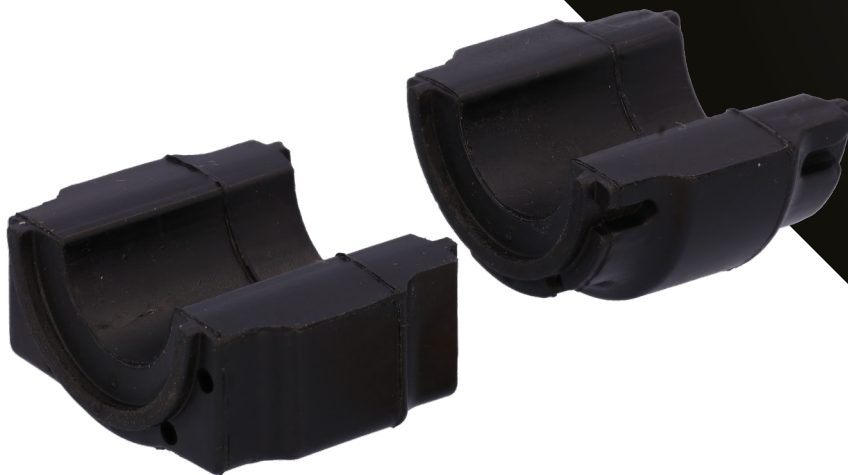
Squeaking and creaking noises from the front suspension when traveling on uneven surfaces.

With age and increased mileage, the anti-roll bar rubber bushes deteriorate and no longer provide the same level of support as when the vehicle was new.

On many Volkswagen Group vehicles built on the MQB platform, the manufacturer does not supply these anti-roll bar bushes separately. SWAG offers them as individual components, allowing for a more efficient repair without the need to replace the entire anti-roll bar.
