FAG Service Info

Potential for Oil Leakage from the Rear Axle

Bleeder Valve Malfunction

Vehicle manufacturer:	DAF
Models:	CF XF
Wheel hub part. no.:	723 5005 10 723 5020 10

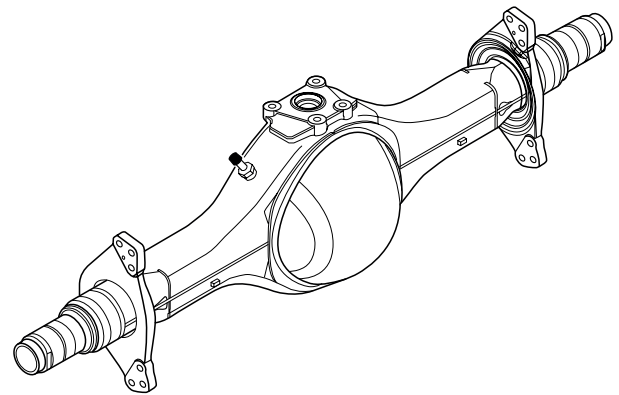
There is evidence that bleeder valves begin to work less effectively or stop working entirely after a long period of operation. This can cause overpressure to build up in the axle casing, which in turn can damage the seals for the wheel hub and the wheel bearings or move these seals out of position. This causes oil to leak from the wheel hubs.

Figure 1: Bleeder valve on the axle for a DAF CF or XF model

Important:
The bleeder valve must always be inspected when installing new wheel hubs or wheel bearings or if there is an oil leak in this area! Where possible, the valve should be removed when carrying out the inspection.
