BMW 1-Series Clutch Replacement

The example featured in this article is a second-generation 1-Series F20 116d equipped with the N47 2.0 diesel engine, which had covered 116,000 miles (187,000 km) and was showing all the signs of requiring a new clutch.

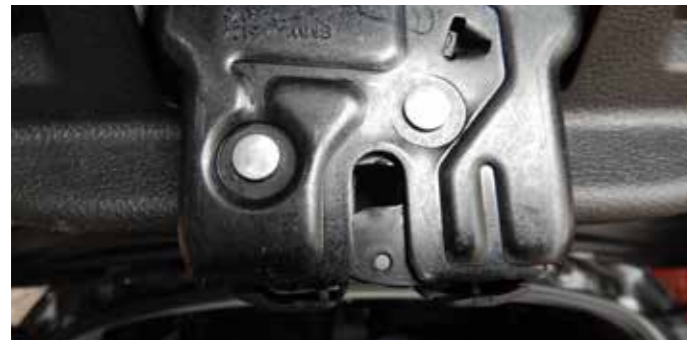
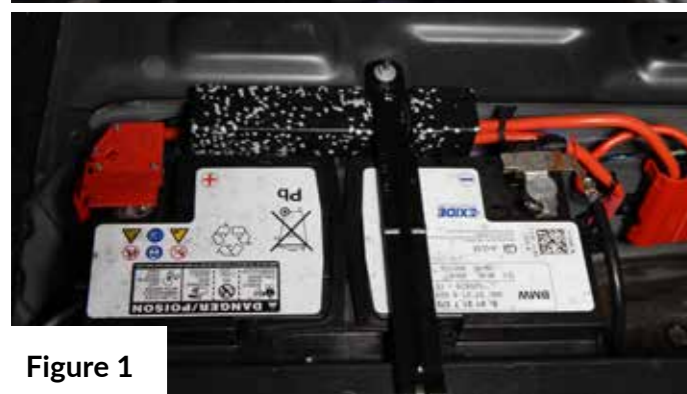
Figure 1

Before the clutch replacement process can begin, the vehicle must be raised onto the ramp in order to lift up the vehicle's tailgate and locate the battery. Remove the negative terminal and set it to one side before lowering the tailgate and setting the latch into the 'shut' position to stop the tailgate from closing completely. This is because, with the battery disconnected, the tailgate latch would remain in the 'shut' position if closed, due to the latch requiring battery power to operate. (Fig.1)

In this instance, the tailgate would not be able to open, making the battery difficult to access for reconnection. All other operations to remove the transmission to gain access to the clutch assembly are from underneath the vehicle.

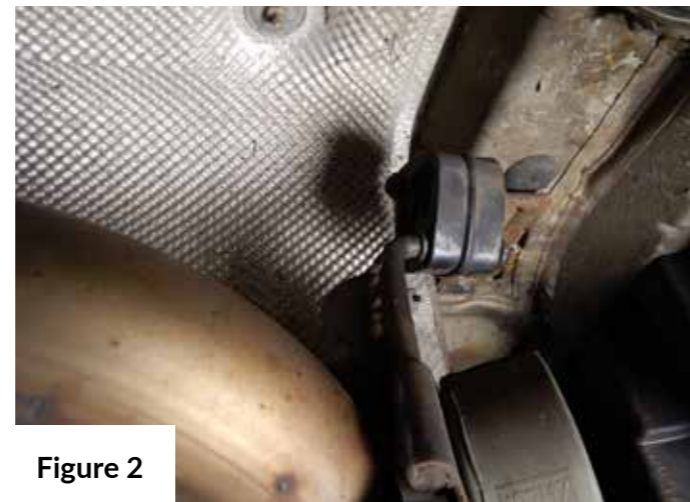
Figure 2

With the vehicle fully raised, the engine and transmission undertrays can be removed, followed by the right-rear exhaust silencer mounting, which allows for the exhaust system to be lowered. Once lowered, there is enough clearance to remove the exhaust heat shields to expose all the fixings to remove the propshaft. (Fig.2)

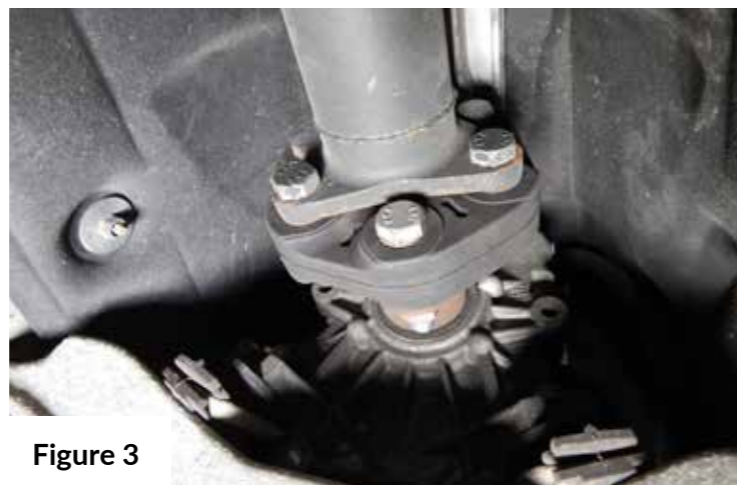
Figure 3

Unbolt the front and rear propshaft couplings (also known as flexible discs), along with the centre support, and remove the complete propshaft from the vehicle. This is a perfect opportunity to inspect the propshaft universal joint for any 'stiffness' or excess play, along with the centre bearing and condition of the propshaft rubber couplings, and to replace any worn parts - if necessary - before reassembly. (Fig.3)

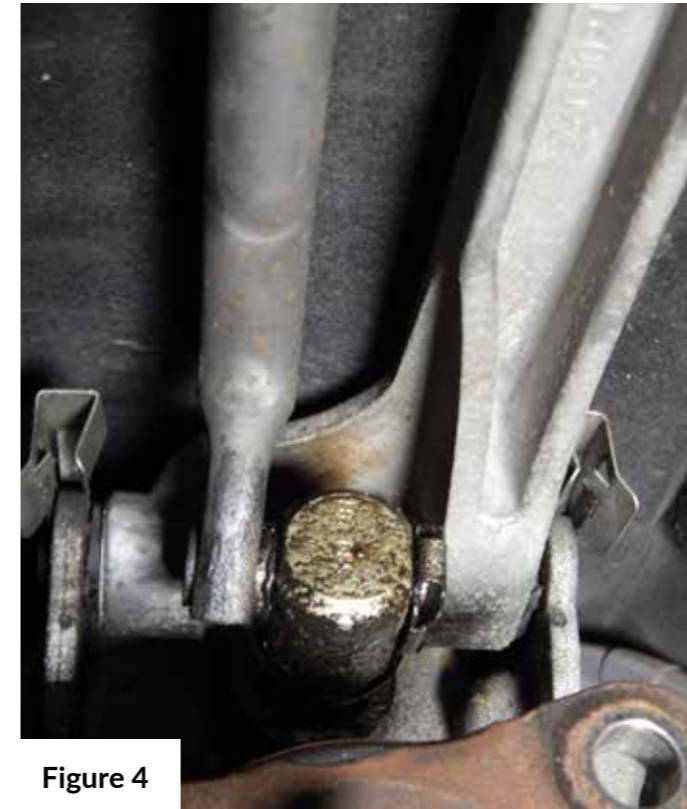
Figure 4

Next, un-attach the gear linkage. There are two pins fixing the linkage to the transmission and one to the gear selector; simply remove them and the linkage becomes separated from the transmission. (Fig.4)

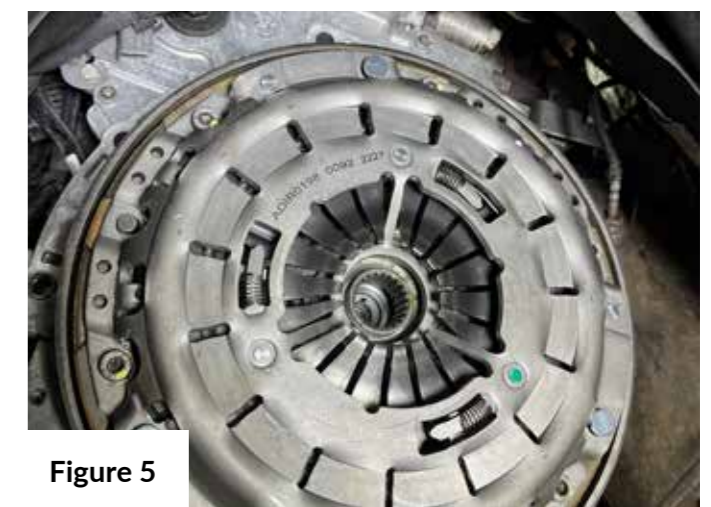
Figure 5

Before fitting any new components, thoroughly clean all mating surfaces at the rear of the engine and the transmission bell housing so they are free of all grease, dirt and old friction fibres from the previous clutch. Then, the new dual-mass flywheel and retaining bolts can be fitted to the engine along with the new clutch kit ADB113017.

Tighten all bolts to the manufacturer's recommended tightening figures, evenly and in sequence, before securing and correctly aligning the components. (Fig.5)

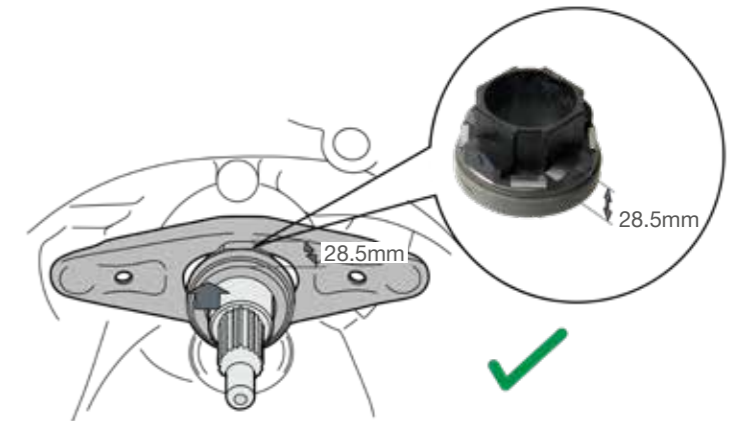
Figure 6

Before refitting the transmission to the engine, assemble the new release bearing with the new release lever and then fit it to pre-greased pivot points to ease operation. **Note:** this clutch kit is provided with an information bulletin, because the release bearing can be fitted at two different points: in this case it is in the 28.5 mm position to provide the correct clearance between the pressure plate and the bearing. (Fig.6)
