Boost controller error due to stiff VTG-unit, cause defective EGR cooler

Vehicle Manufacturer: VW

Vehicle: Crafter, Amarok 2.0 tdi

BTS reference: T916320 **BTS-Service-Set-Nr:** Txxxxxxxxx

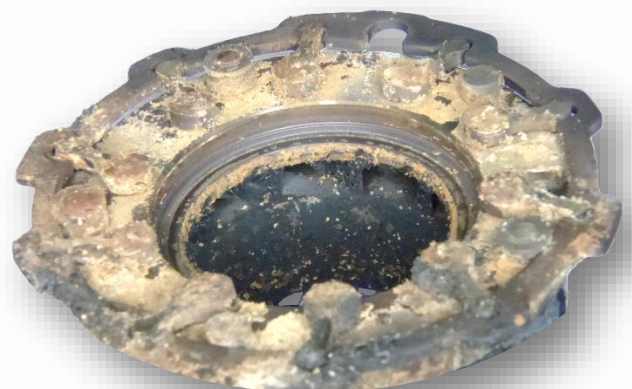
Examine the turbocharger to be replaced in the exhaust manifold and turbine exhaust for deposits of rust or light lime scale. If the EGR cooler leaks, after shutting off the engine, cooling water presses into the exhaust manifold and into the VTG unit of the turbocharger. There it comes to corrosion and lime scale deposits, which leads to the stiffness up to the blocking of the VTG. Even small amounts of cooling water loss are sufficient.

Check the EGR cooler for leaks in the cooling water circuit and replace if necessary. So an expensive repetition damage can be avoided at the new turbocharger.
