febi 172813

Ignition Switch

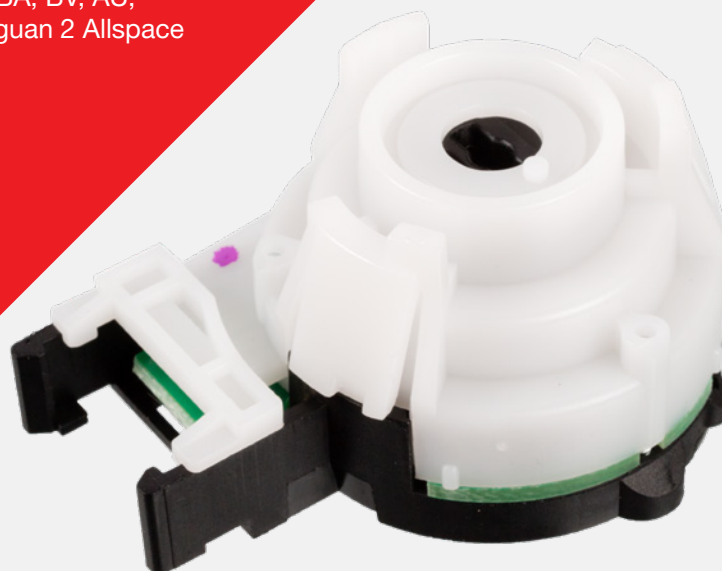
The engine remains running when the ignition key is turned to the 'off' position but stops when the key is removed. Using a suitable diagnostic tool can show the following fault codes:

A fault can occur in the switch caused by internal tolerance issues which prevent the contacts from aligning correctly.

Check the continuity of the wiring loom to the ignition switch, if the readings are correct then proceed with changing the ignition switch. febi replacement part 172813 is manufactured to match the latest (modified) version. febi also has the ignition lock housing in range under article number 36044.
