Optimized tensioning pulley 531 0564 30

1.4i 16V (AFH)

LuK AS Part No.: 531 0564 30

INA 0009

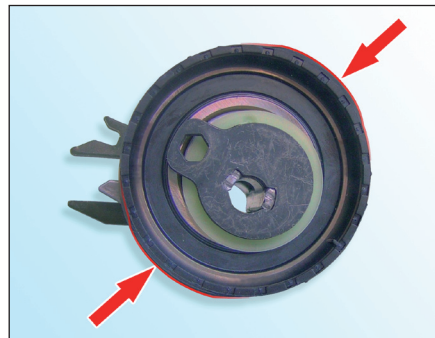
Fig. 1: 531 0564 30 (front view)

Tensioning pulley **531 0564 30** (sinus pulley) is a noise-optimized tensioning pulley, developed specially for the applications outlined above.

The red markings (**fig. 1** and **fig. 2**, arrows) highlight the features.

The unusually formed running surface is **not** a production fault!

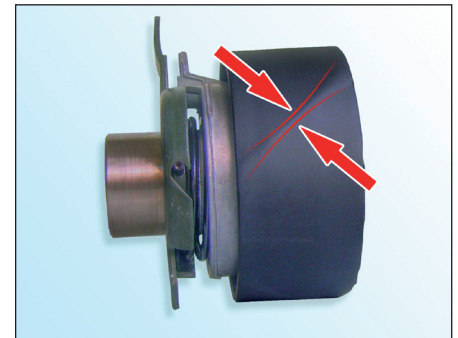
Fig. 2: 531 0564 30 (side view)

The running surface of the tensioning pulley has diagonal elevations (**fig. 2**).
