# Blue Print ADB112512, ADB112513

BMW 1 Series (F40), 2 Series (F44, F45, F46),  
X1 (F48), X3 (F39). MINI (F54, F55, F56, F57, F60)

## Cabin Filter Set

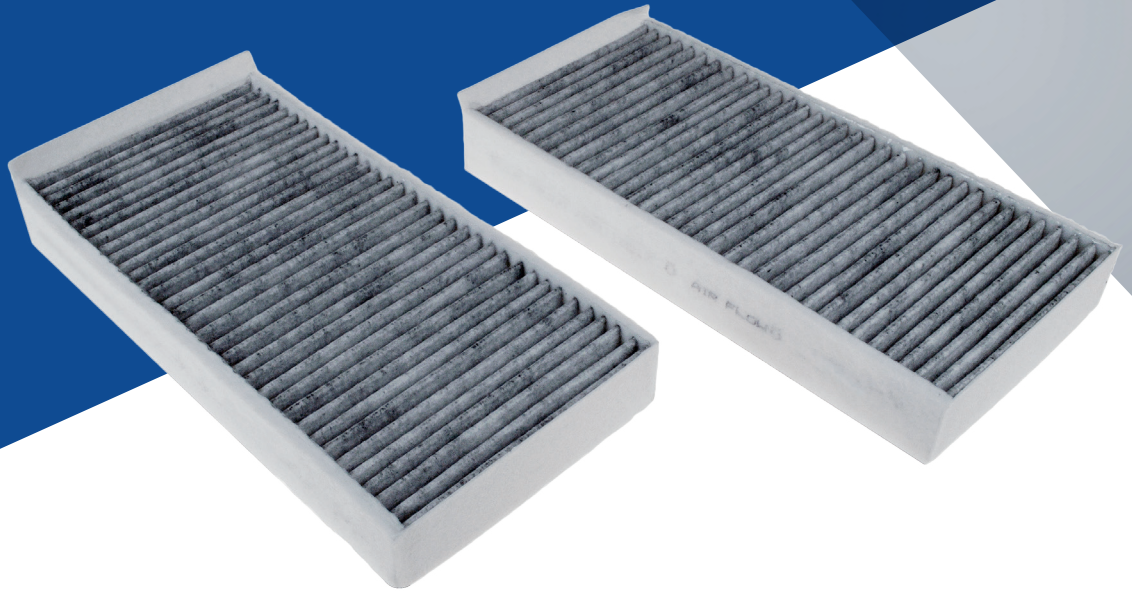
Front footwell carpets are wet. On removal of the cabin filter during routine maintenance it is found to be moist and has started to become moldy, causing odour within the car.

The heater housing evaporator drain is blocked or excessive leaf litter within or near the heater intake is causing an obstruction. Another possible cause is that the air conditioning housing access cover - located next to the cabin filter service cover - is incorrectly fitted and allowing condensation to leak into the vehicle's interior.

Remove any leaf litter from the heater intake and check and clear the heater housing drain tube. Take off the air conditioning evaporator housing access cover and check that the mating surfaces will provide a good seal. Refit and apply pressure while tightening the retaining screws.

For vehicles equipped with climate control replace the cabin filter with Blue Print part ADB112512 activated charcoal filter. For vehicles without climate control use Blue Print part ADB112513.
